**Report of Dr. Brenton Cox
Regarding the May 31, 2017
Explosion at Didion Milling in
Cambria, Wisconsin**

March 31, 2023

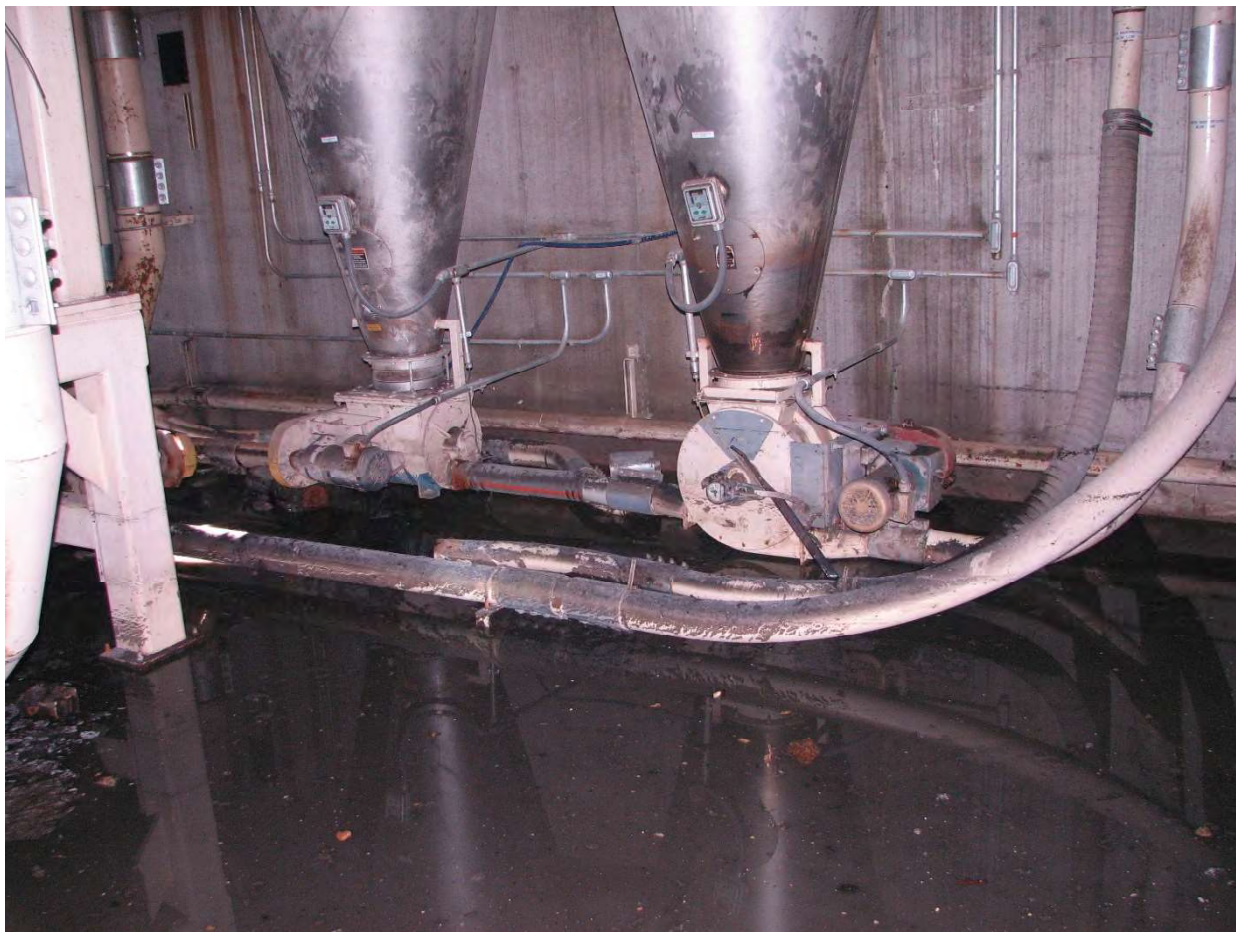
D16672 - 0157

Not shown in the PFDs is a Management of Change (MOC) performed on May 3rd, 2017, which allowed for the incorporation of the NBM into the Bran System.⁷¹ The change managed by this MOC was the connection of the “North Bauermeister blower line after [the] cyclone airlock to South Bauermeister cyclone airlock to use both [B]auermeister’s for bran production.”

Figure 16. Picture the as-found configuration, combining the discharge of the SBM Cyclone (left) and NBM Cyclone (right).

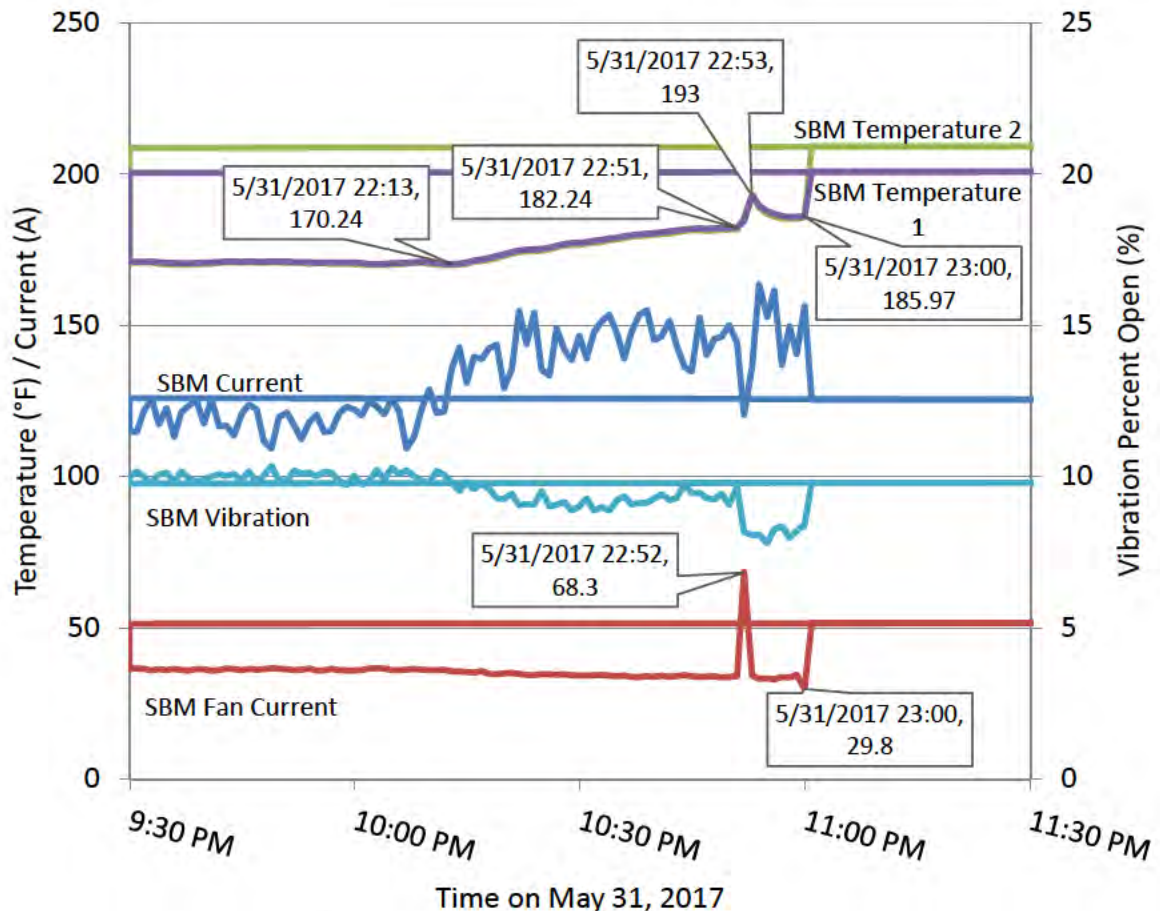
SBM gradually rose from about 170 to 182°F, concurrent with an increase in motor amps and decrease in vibration (Figure 23).⁹⁶ At about 10:45 PM or 10:50 PM, operators reported smoke and began searching for its source (see Section 2.6.4). At around 10:53 PM, the SBM temperature spiked to 193°F with a spike in fan amps occurring just before. The explosion occurred at about 11:00 PM following a small decrease in fan amps. At 11:01 PM, all data ceased.

Figure 23. Temperatures, currents (amps), and vibrations recorded for the South Bauermeister (SBM) on the evening of May 31, 2017.⁹⁷

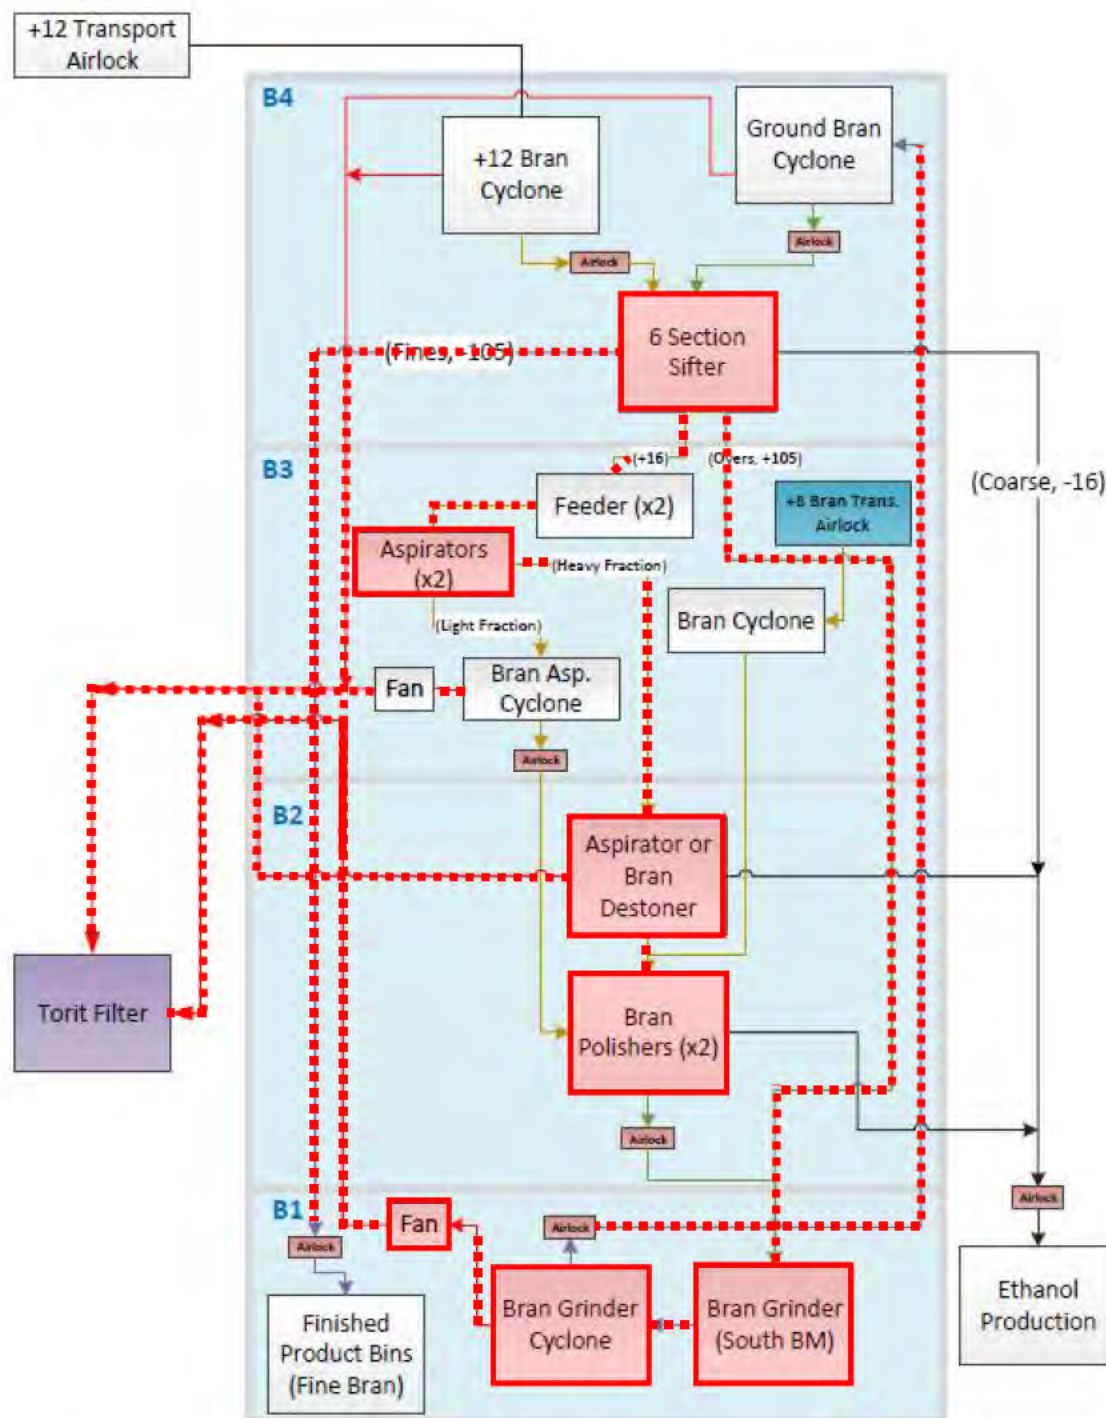
As described by the witness statements (refer to Section 2.6.4), an initial “boom” was heard, the air-intake suction line filter “blew off,” and two separate instances of flame emerged out of the air-intake suction line. These first two flames represent the first observed propagation of the flame internally from the SBM. This section discusses additional evidence of internal flame propagation and overpressure experienced in the Bran System in the B-Mill. Damage consistent with internal propagation was observed throughout the B-Mill, including the propagation pathways highlighted in Figure 27.

Figure 27. Damage observed though post-incident photo documentation in the Bran System in the B-Mill shown in red. Additional damage may have occurred in equipment that was not accessible and/or was damaged during demolition.

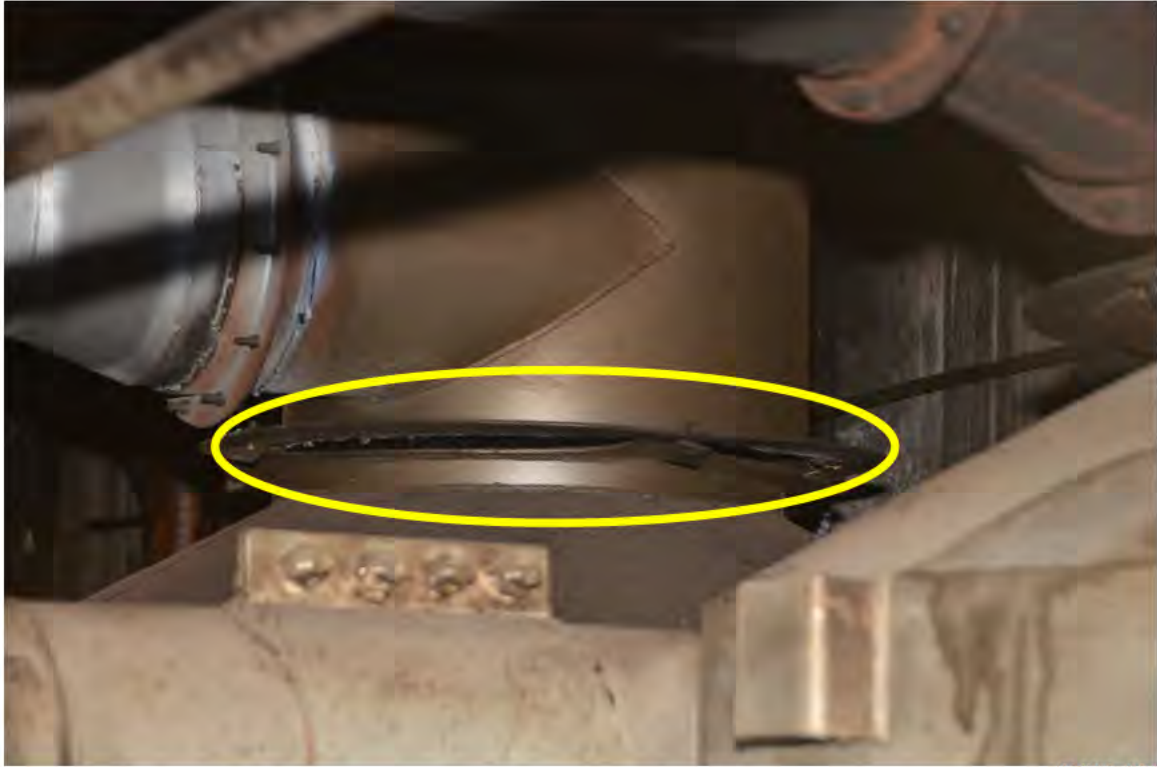
D16680 - 0206

Figure 30 and Figure 31 show evidence of an internal overpressure event as well as discoloration due to heat and flame effects. This overpressure resulted in separation at a connection near the top of the SBM Cyclone (Figure 30). The disparity in appearance between the BM Cyclones is consistent with increased heat exposure localized to the SBM Cyclone, from either a prolonged internal fire or a sustained flame emitting from the separation.

Figure 30. Top of SBM Cyclone duct that feeds into the SBM Fan post-incident. The separation occurred at the connection indicated by the yellow arrow as internal overpressure lifted the top of the SBM cyclone. This is unequivocal evidence of internal propagation downstream from the SBM.

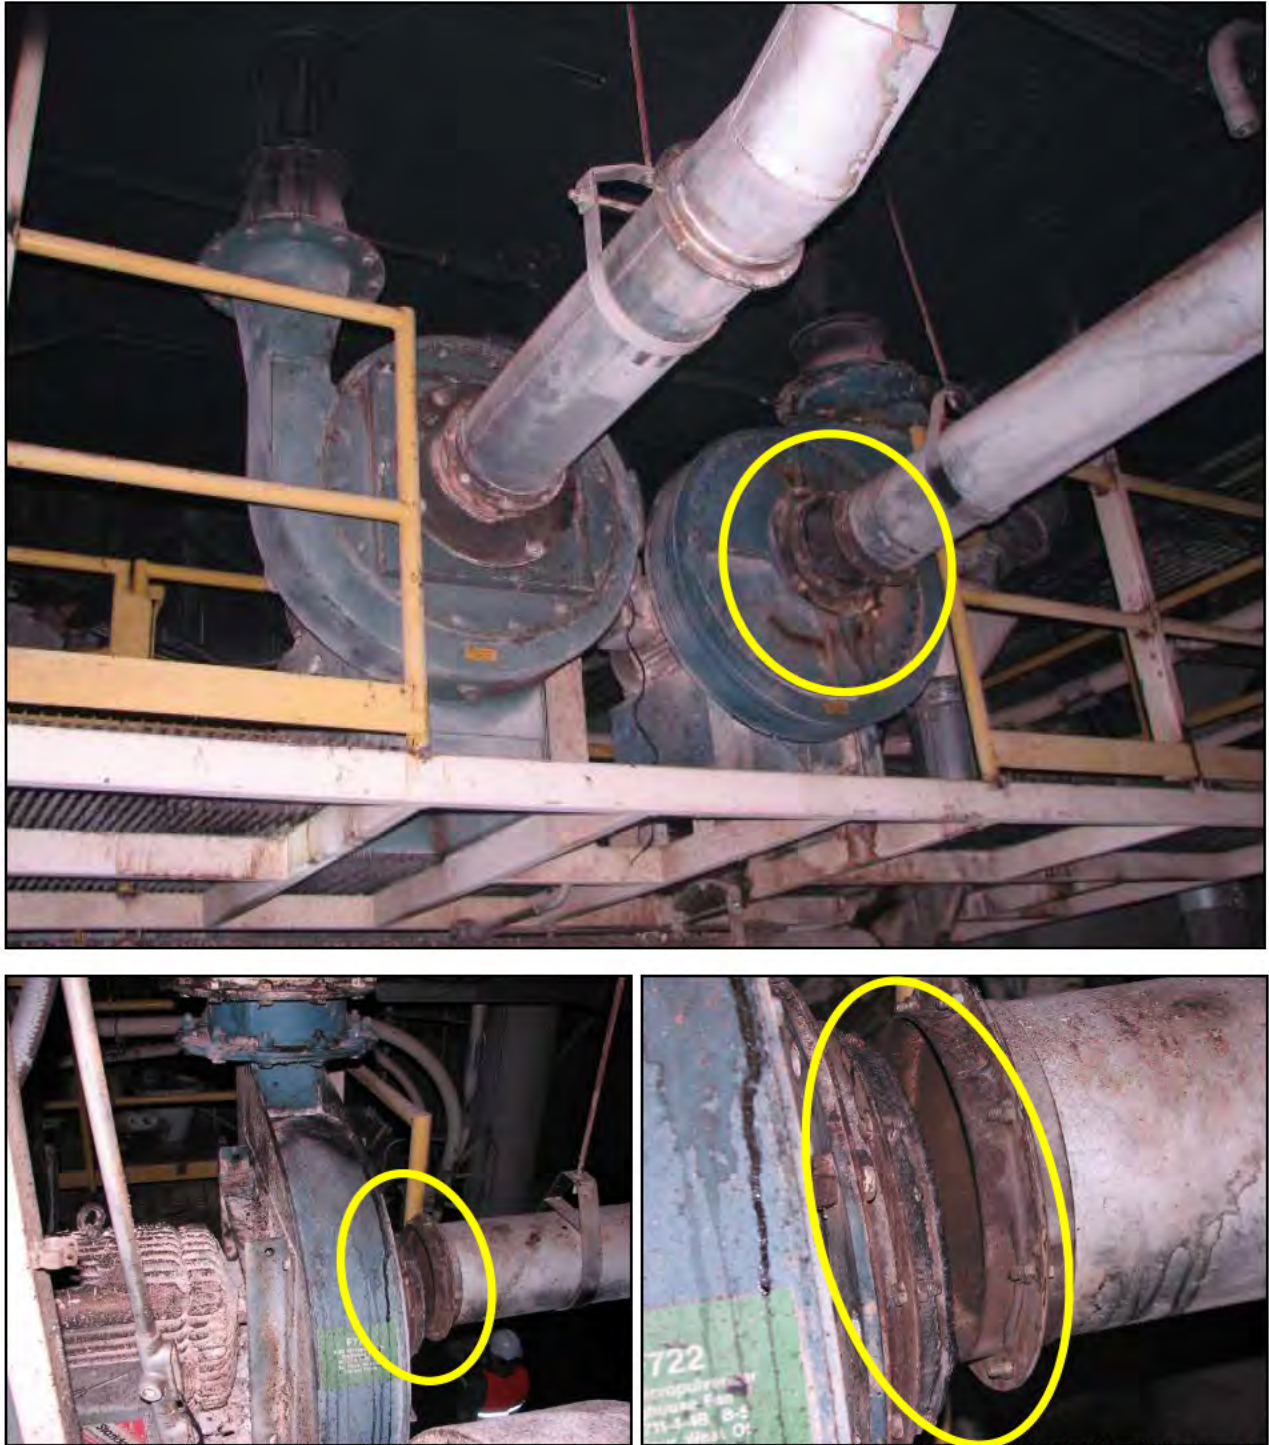
D16682 - 0228 (top); D16682 - 0046 (bottom - left); D16682 - 0049 (bottom - right)

Figure 31. Post-incident view of NBM Fan (top left) and SBM Fan (top right) on the B1 mezzanine with zoomed in photos of the SBM Fan (bottom left and right).

Incontrovertible evidence of flame propagation through the SBM Fan is shown in Figure 31. The flexible connection between the SBM Fan and its inlet duct was destroyed during the event,

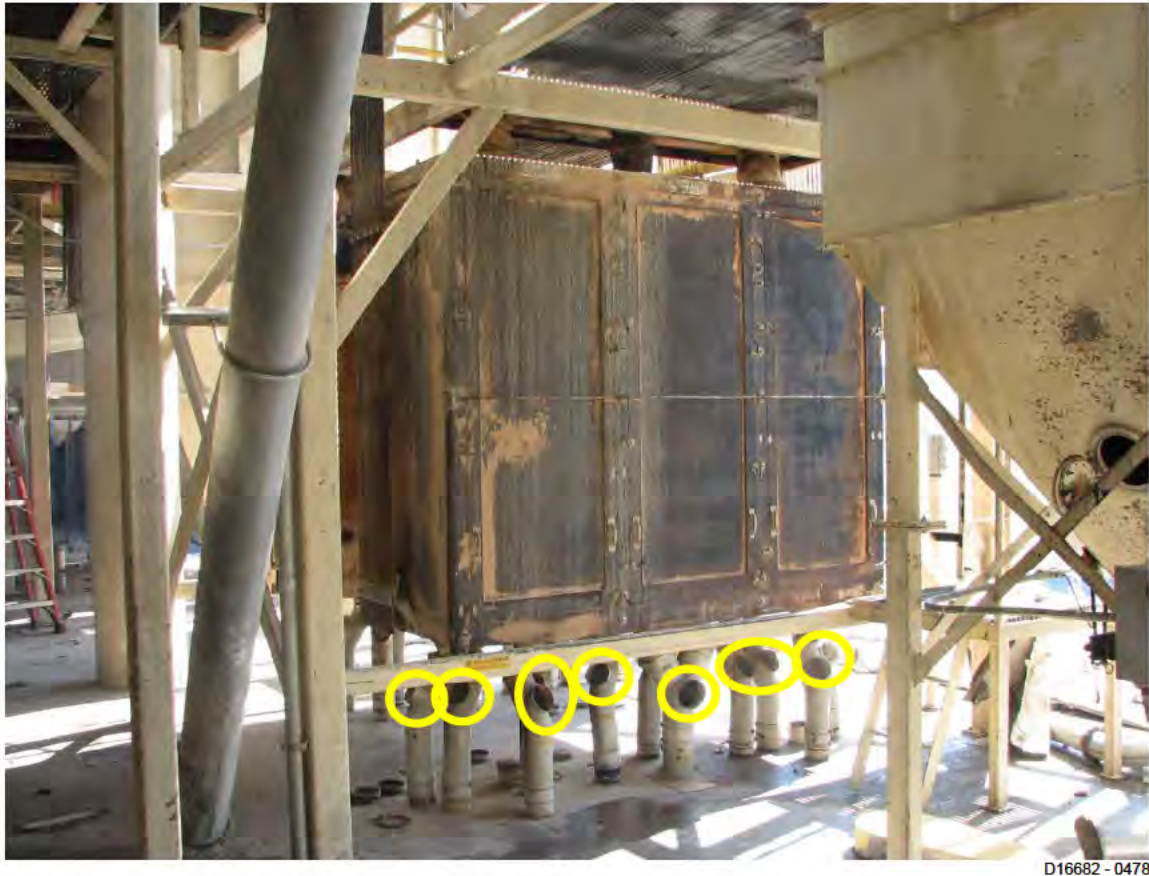
D16682 - 0478

As shown above in Figure 27, the SBM is fed by a line comprised of the +105 overs from the 6 section Bran Sifter on B4 and the two Bran Polishers on B2. The process flow diagram demonstrates that flame/pressure had multiple pathways to propagate through the +105 overs line to the 6-section Bran Sifter on the 4th floor of the B-Mill from the SBM as well as through the bottoms of the SBM Cyclone in B1. Photographic evidence demonstrates that such propagation reached the 6-Section Bran Sifter (Figure 32) as observed with the caps missing from the bottom ducts, suggesting that they were blown off due to internal overpressure.

Figure 32. Post-incident view of 6-Section Bran Sifter on 4th floor of B-Mill (B4) with detached caps.

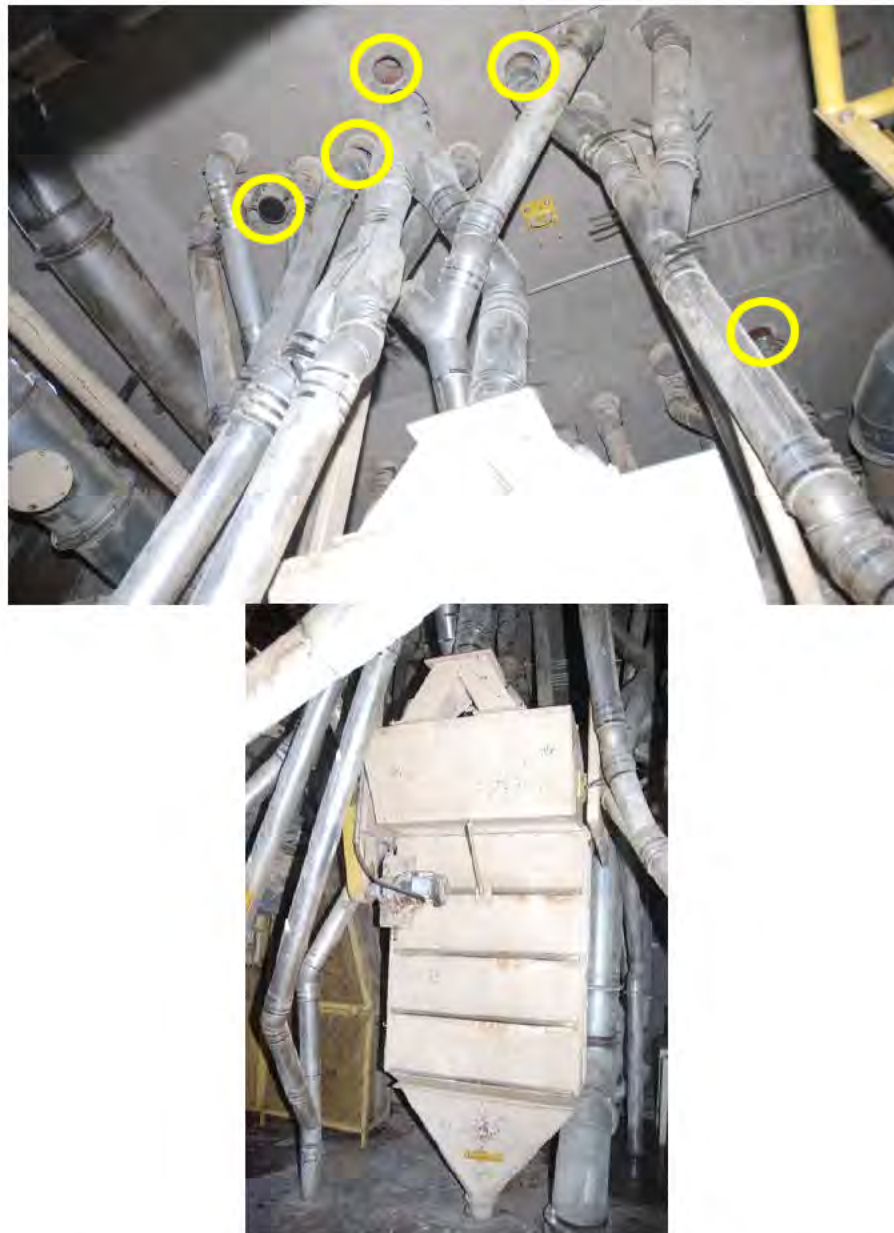
D16686 - 00996 (bottom), D16686 - 00998 (top)

Figure 34. Post-incident view of South Bran Aspirator on the 3rd floor of the B-Mill (bottom). Disconnected ducts can be seen at the ceiling level (top)—these ducts carried the discharge from the 6-Section Bran Sifter.

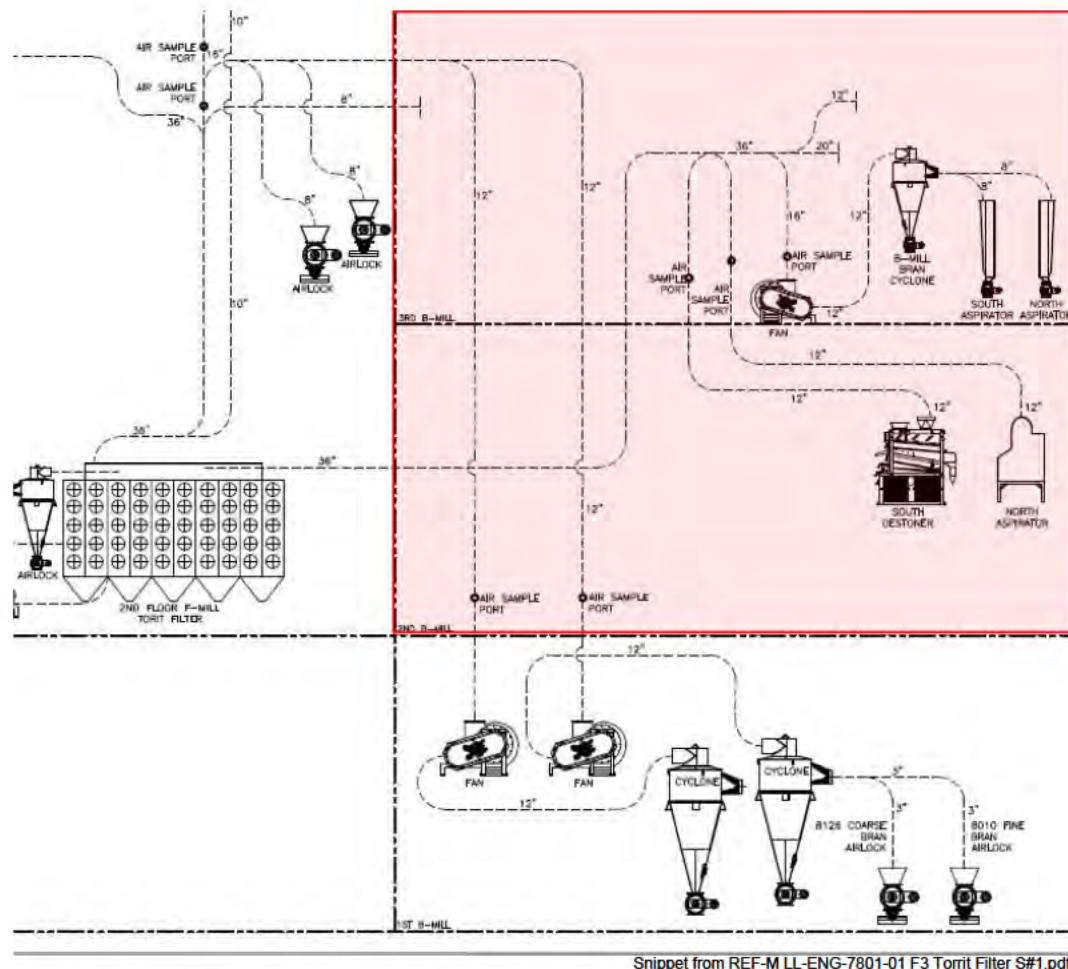
ducting on the 3rd and 2nd floor of the B-Mill. Evidence of flame and internal overpressure having propagated through the Torit Filter Header were observed in B3 and B2. Figure 35 shows the 36" Torit Filter Header in the center of the 3rd floor of B-Mill which contains 2 blinds: a 12" line and 20" line. No other PFDs for the facility have this combination of blinded lines. These two lines were photographed during the inspection after the incident and are shown below in Figure 36.

Figure 35. Torit Filter ducting in the B-Mill (1st, 2nd, and 3rd floor) with 2nd and 3rd floor highlighted in red.

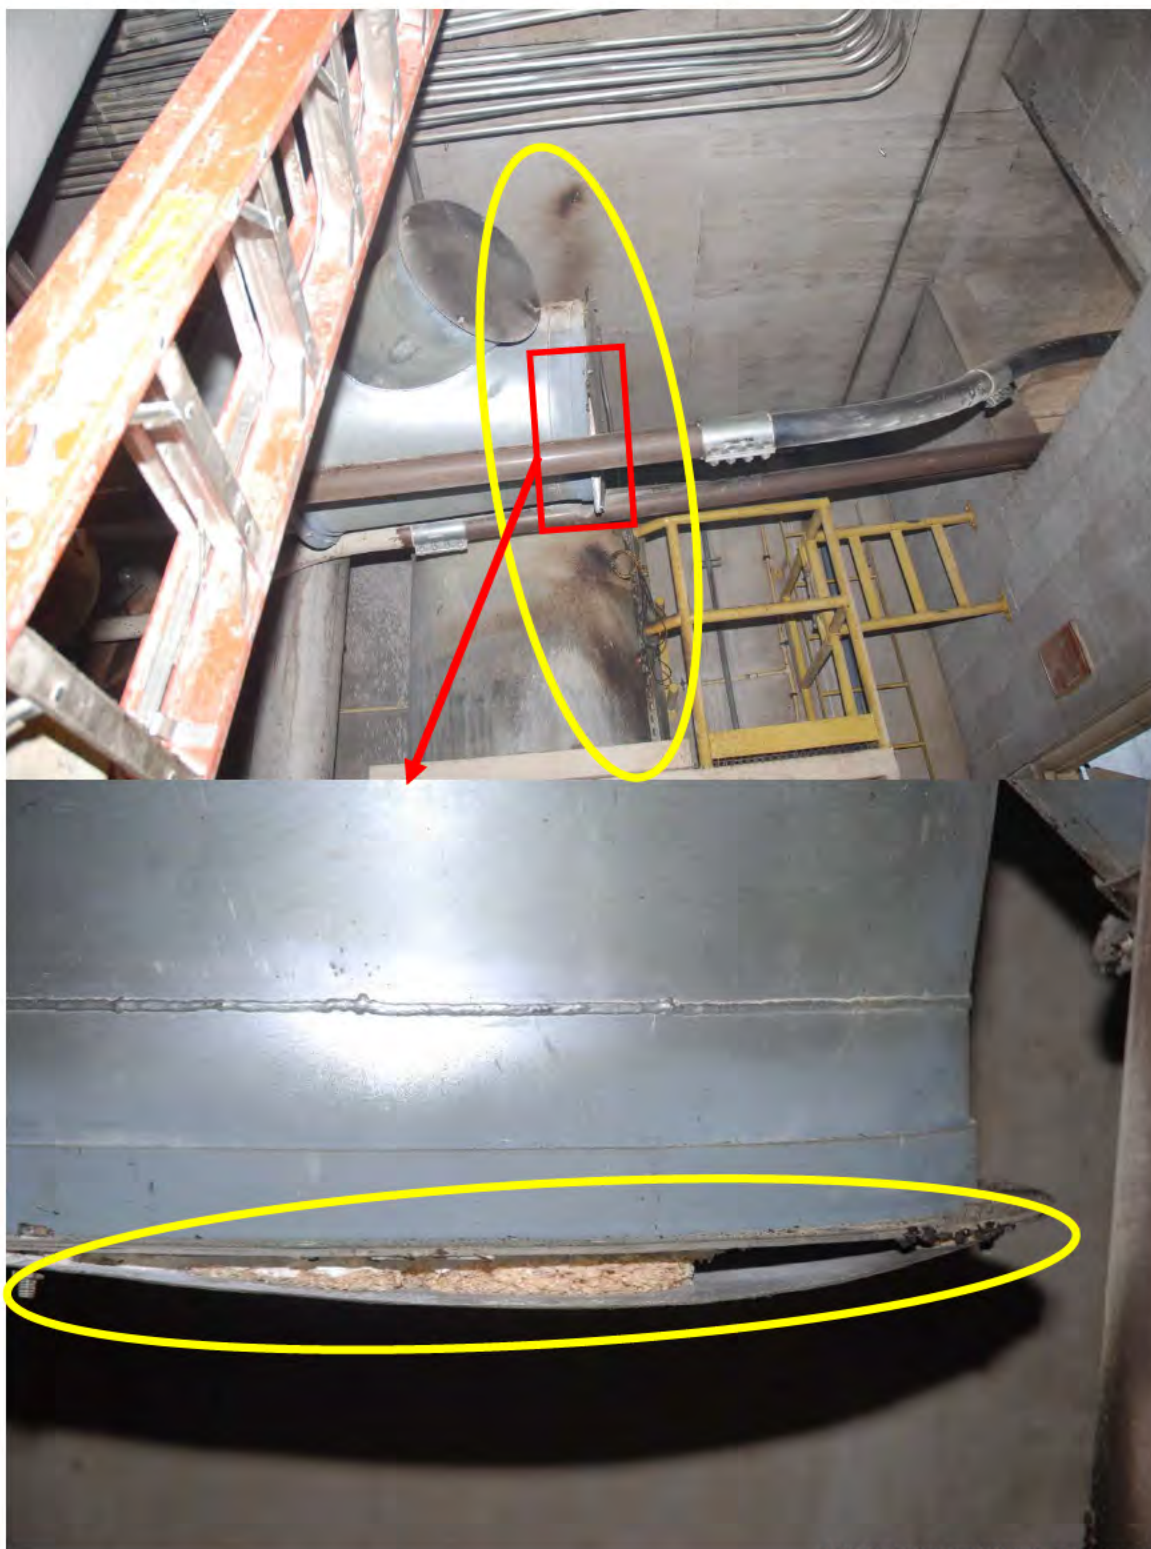
D16686 - 00959 (top) D16686 - 00961 (bottom)

Figure 36. Post-incident view of 12\" and 20\" blinded lines that were connected to the 36\" Torit Filter Header in B3 (top) and zoomed-in end of 36\" line (bottom).

The top image in Figure 36 depicts both the 12” and 20” blinds. Remnants of burned, expelled product from the end of the 20” line were observed on surrounding walls and ceiling, which appear as scorch marks. A closer view of the scorch marks, shown in Figure 37, reveal the texture created by partially burned material that was ejected from the 36” duct. The 20” blind itself is observed to be deformed (Figure 36) from the overpressure experienced by the Torit Filter Header in B3.

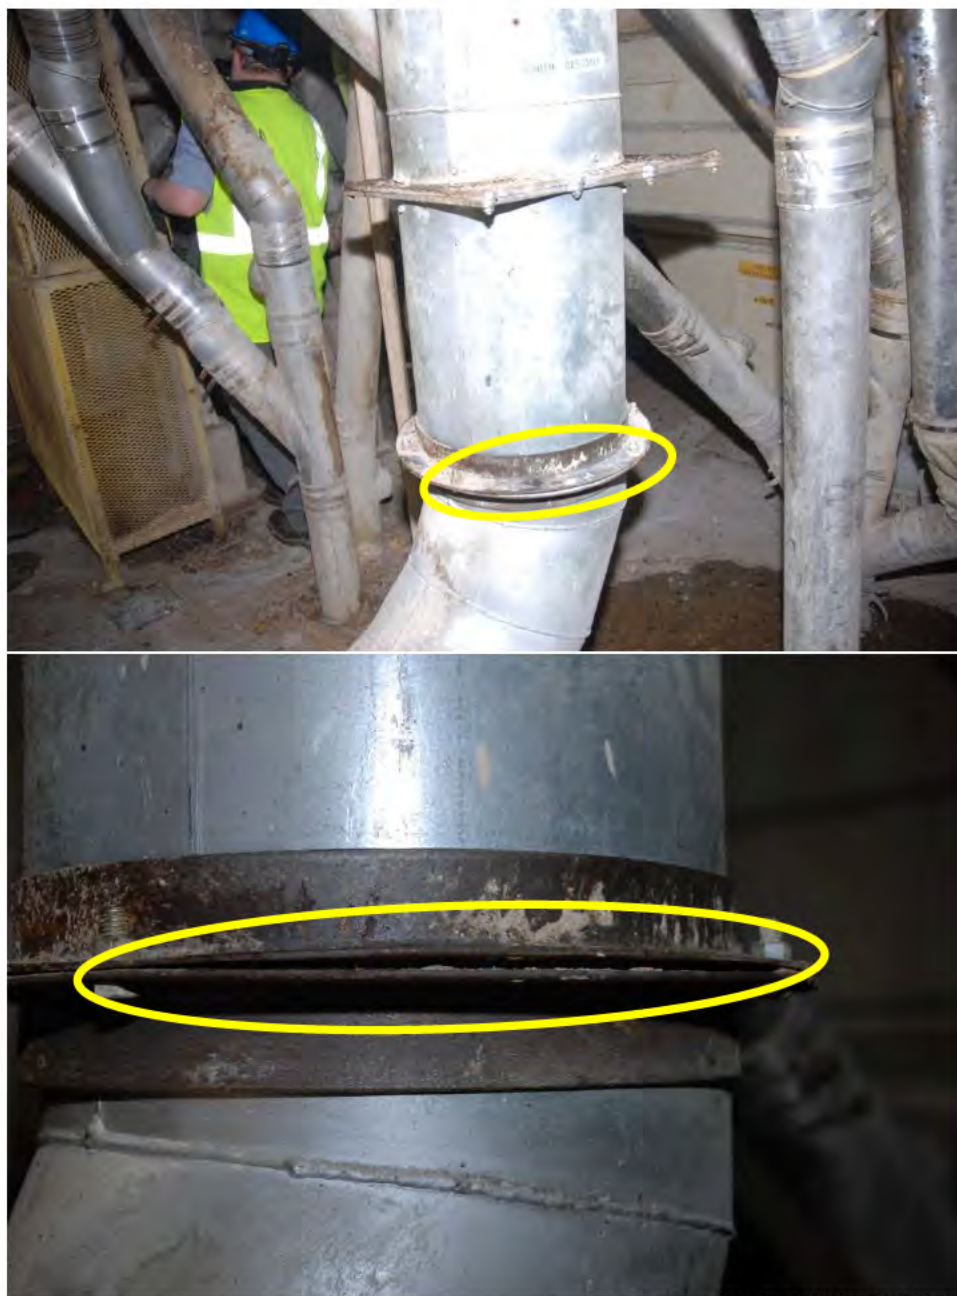
D16686 - 00990 (top) D16686 - 00992 (bottom)

Figure 38. Post-incident view of a flanged connection on B3 on a line that connects the Torit header on B3 and the South Destoner on the B2.

From Figure 38, an overpressure event inside the ducting resulted in deformed metal at the flanges connecting the ducting. This is consistent with the overpressure and burn patterns observed in Figure 36 for the 12" and 20" blinded lines connected to the 36" Torit Filter Header.

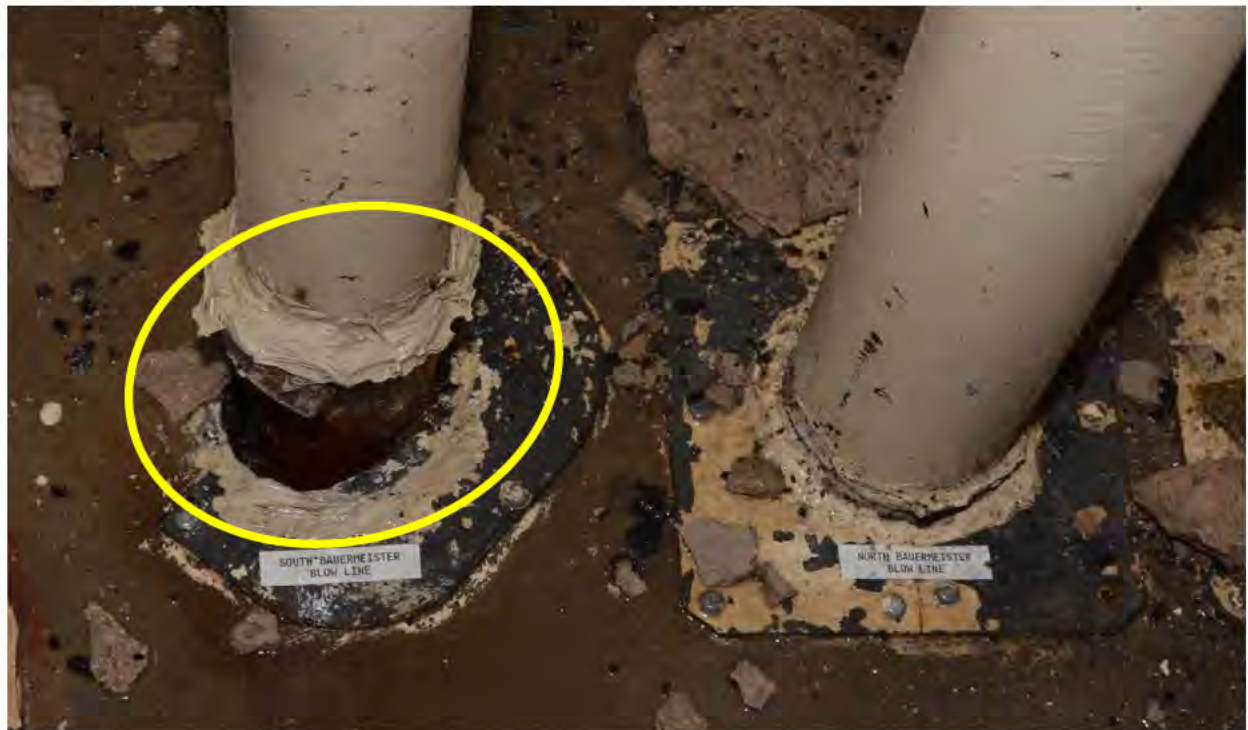
D16680 - 0749

In addition to the equipment and ducting on the 3rd floor of the B-Mill, Exponent has documented evidence consistent with internal propagation through the pneumatic conveying line ("Blow Line") leading from the SBM Cyclone discharge to the Ground Bran Cyclone on B4. As seen in Figure 39, the SBM blow line is fully separated from the floor on B3. This separation is consistent with an internal overpressure event that occurred in the SBM line with flame/deflagration propagation through the lines.

Figure 39. Post-incident view of ducting to SBM Blow Line (left) and the NBM blow line (right), which transport product from B1 to B4.

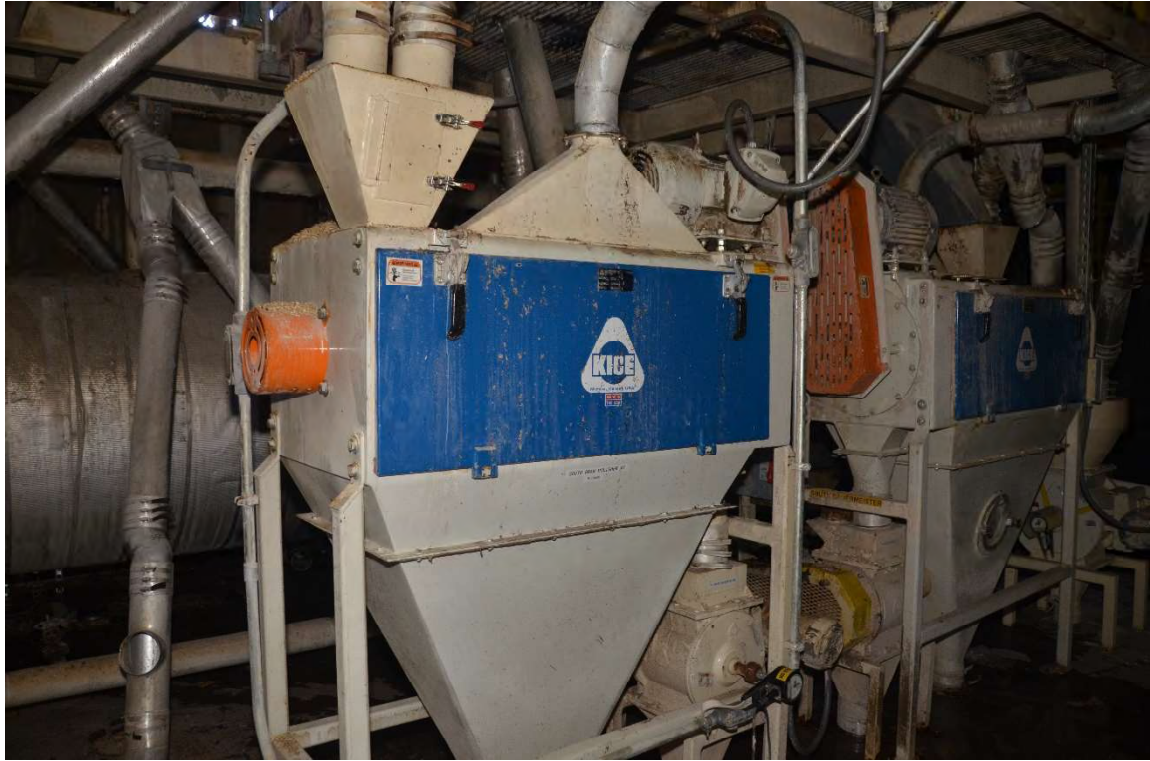
D16680 - 0620

Figure 41. Post-incident view of both North and South Bran Polishers located on the 2nd floor of the B-Mill (B2).

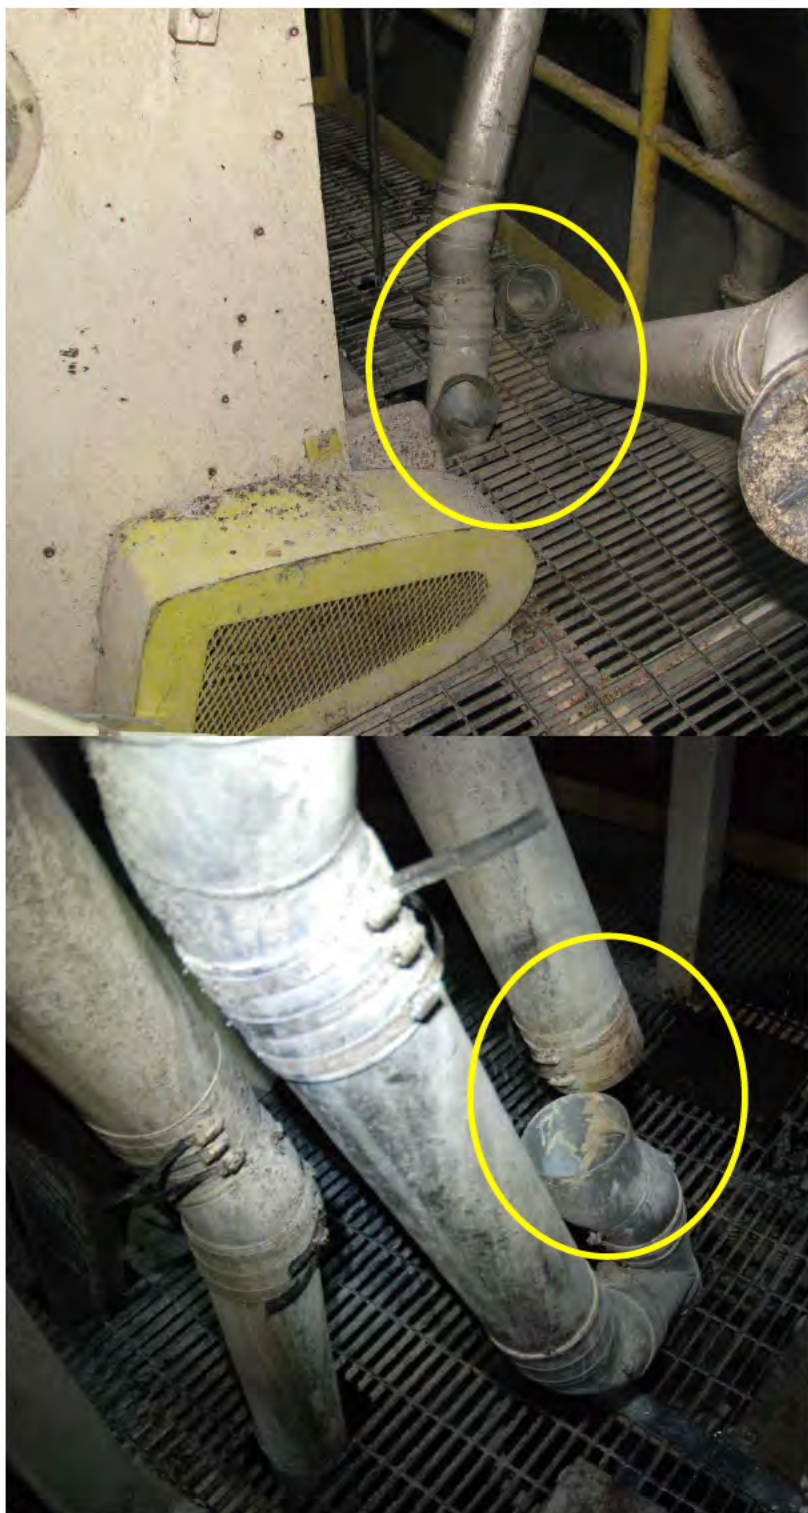
D16677 – 0756 (bottom), D16682 – 0274 (top)

While it is difficult to see an overpressure event or burn patterns on the inside of the Bran polishers, evidence of internal overpressure events was observed on ducting connected to the Bran Polishers (Figure 42).

Figure 42. Post-incident view of separated ducts both to the South Bran Polisher (top) and to the North Bran Polisher (bottom).

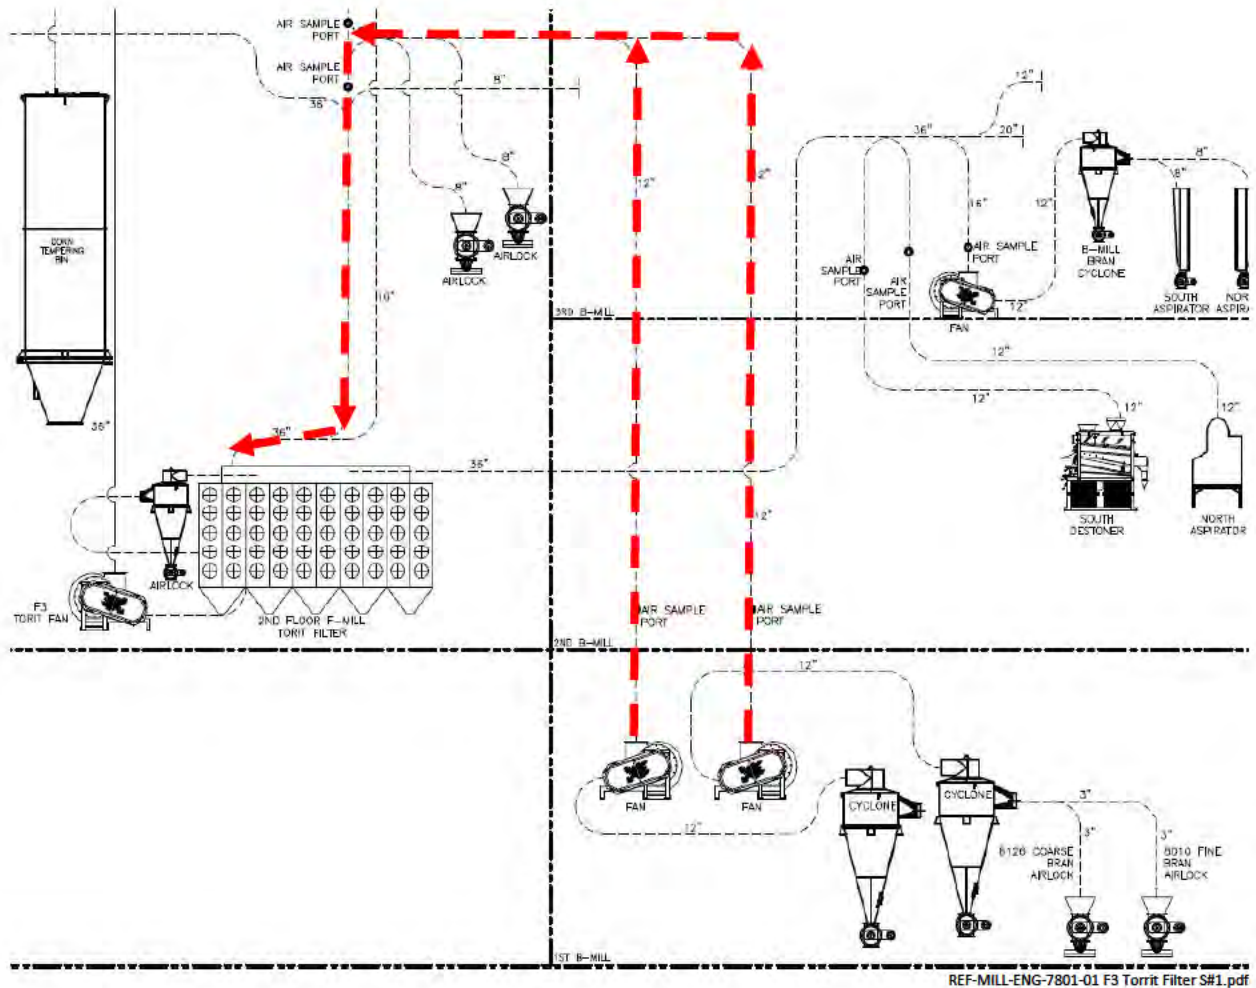
Figure 44. PFD of ducting from Bran Grinder Cyclones to Bran Grinder Fans to ducting into the Torit Filter (located on the 2nd floor of the F-Mill) with propagation pathways shown in red.

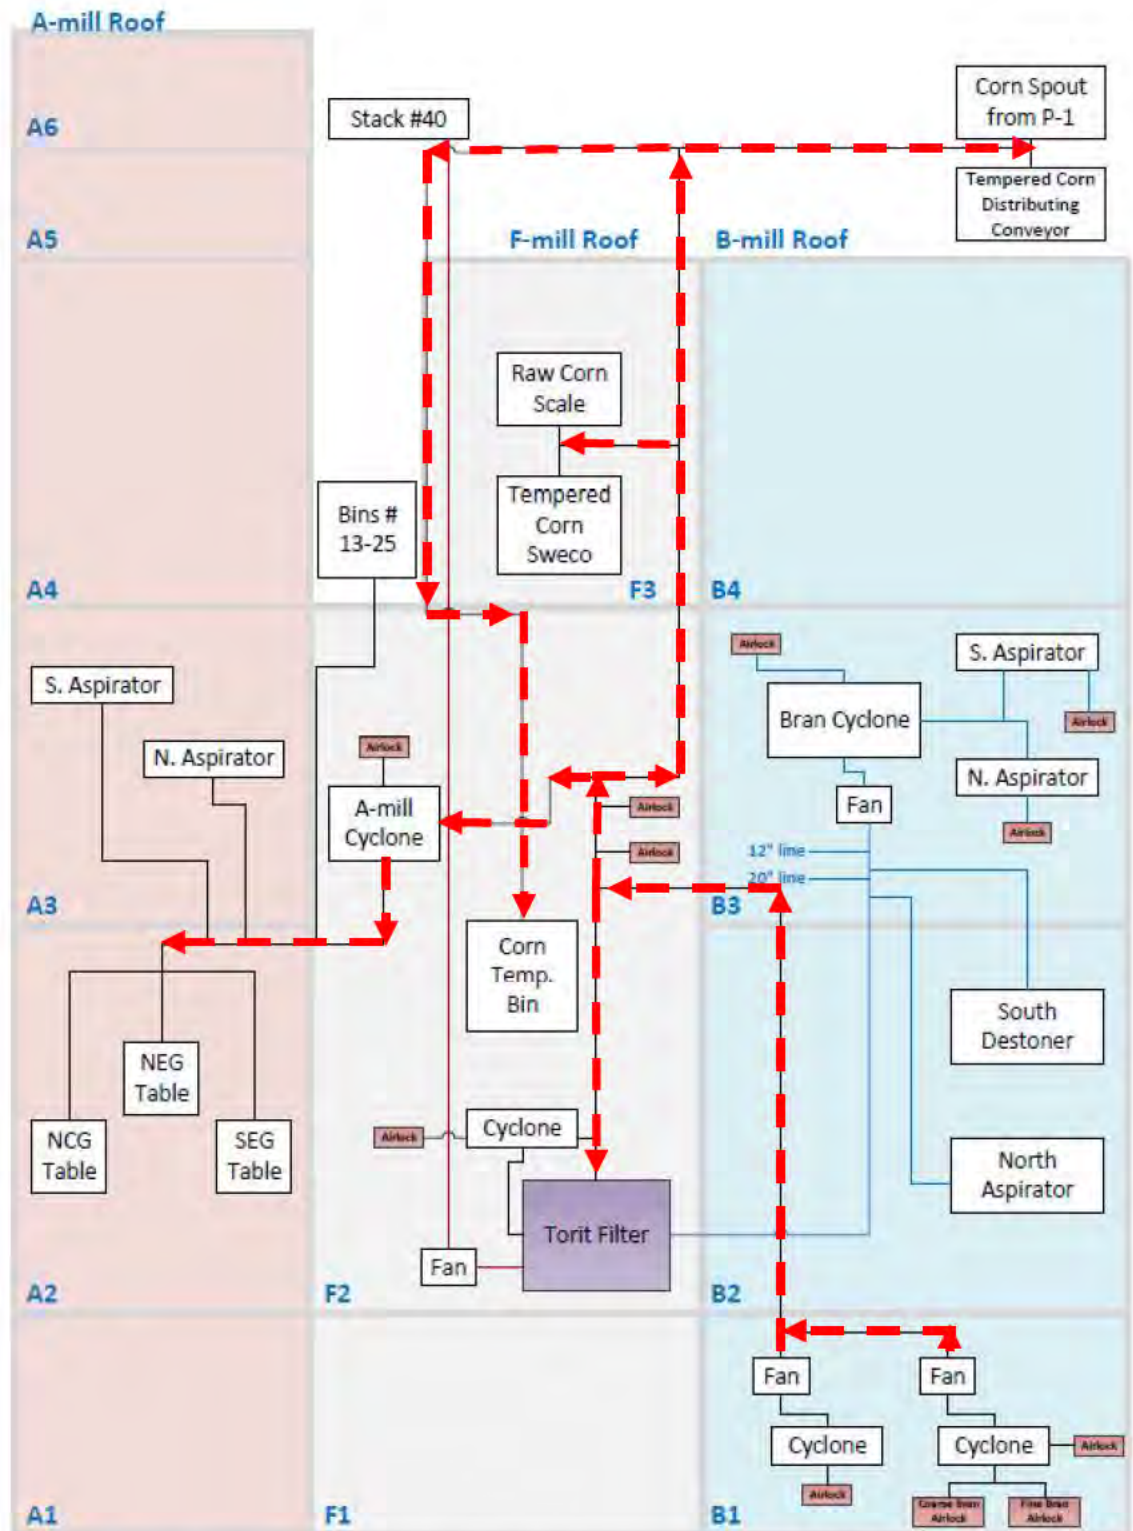
Figure 45. PFD of Torit System in B-Mill, A-Mill, and F-Mill with propagation pathways shown in red.

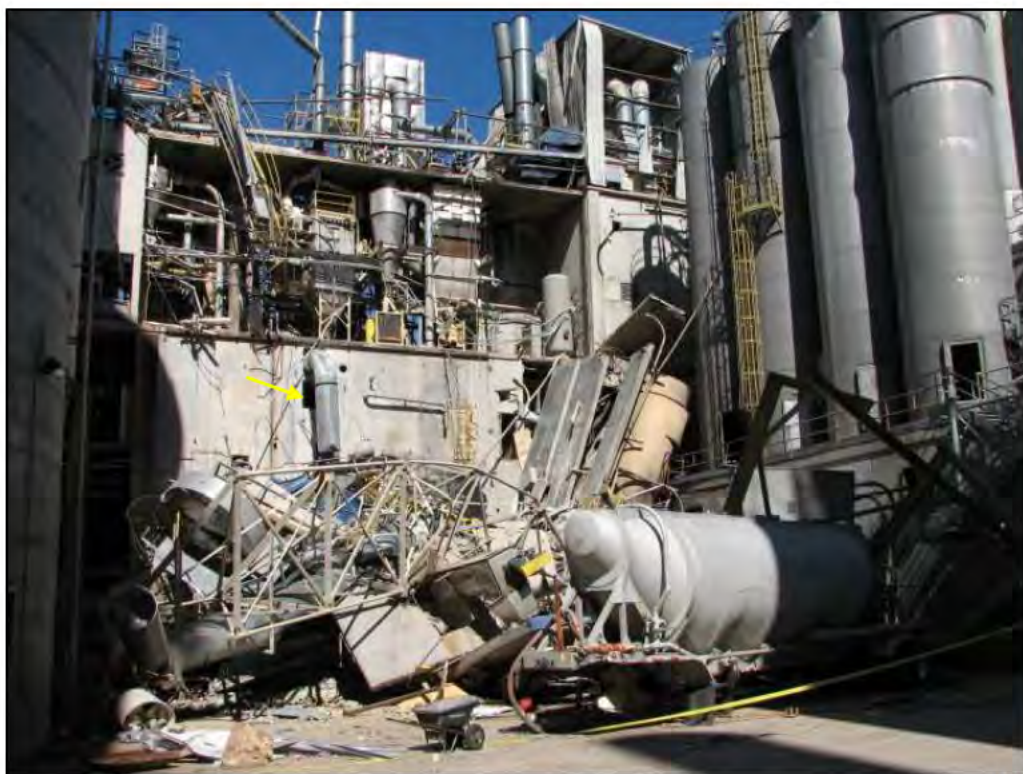
D16649 - 0033

The Torit Filter was located on the 2nd floor of the F-Mill (F2).¹⁸⁹ Although access to the remnants of the F-Mill post-incident was restricted for safety reasons, the Torit Filter was identified through photography and drone footage and was ultimately recovered. The Torit Filter itself can be seen as the large blue piece of equipment label “Torit Downflo” in Figure 47. The 36” header into the Torit Filter is detached but can be seen protruding from wall of the 3rd floor of the B-Mill in Figure 46.

Figure 46. Post-incident view of duct (see yellow arrow) protruding from the 3rd floor of the B-Mill into the blue Torit Filter (located on what used to be the 2nd floor of the F-Mill).
